NASA Technical Memorandum 4017

Pultrusion Process Development for Long Space Boom Model

Maywood L. Wilson and Robert Miserentino

Langley Research Center

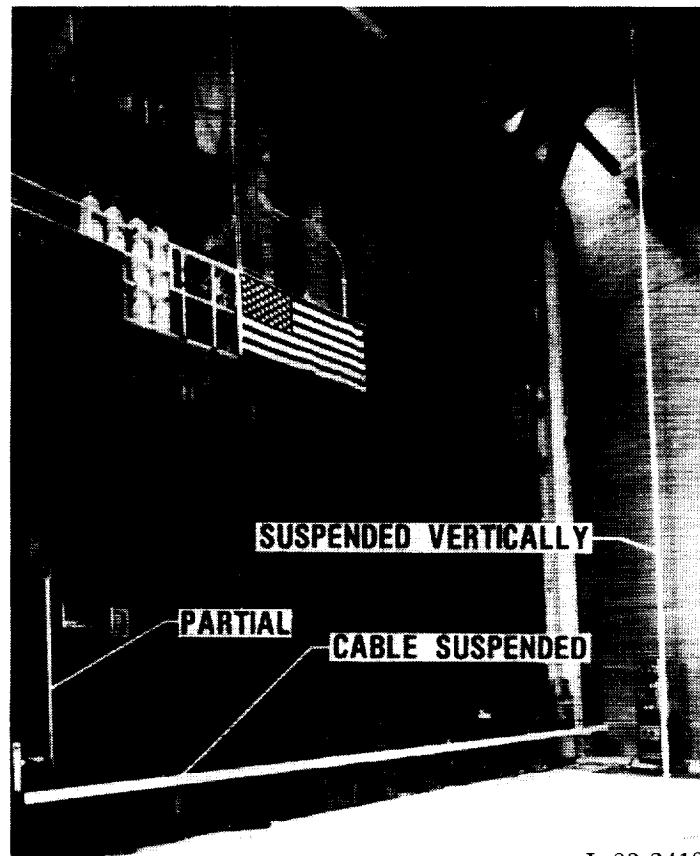
L-83-2412

Figure 1. Dynamic tests of boom models.

Pultrusion is not a new process, it was initiated in the early 1950's. (See ref. 1.) It is, however, still in its infancy in the aerospace industry. The NASA Langley Research Center (LaRC) in Hampton, Virginia, and the U.S. Army Materials and Mechanics Research Center (AMMRC) in Watertown, Massachusetts, are the only government facilities that have in-house pultrusion laboratories with ongoing research and development in pultrusion materials and processes. Experiments are being conducted at LaRC for pultrusion in advanced-composites technology with applications to aeronautical and space structures. In one such program, long flexible beams were needed to establish ground-vibration test methods for very-low-frequency structures. The beams were rectangular in cross section, 0.250 in. in thickness, 4.000 in. in width, and 32.81 ft in length; the beams weighed 25.6 lb each. In figure 1, suspended beams are shown undergoing dynamic tests.

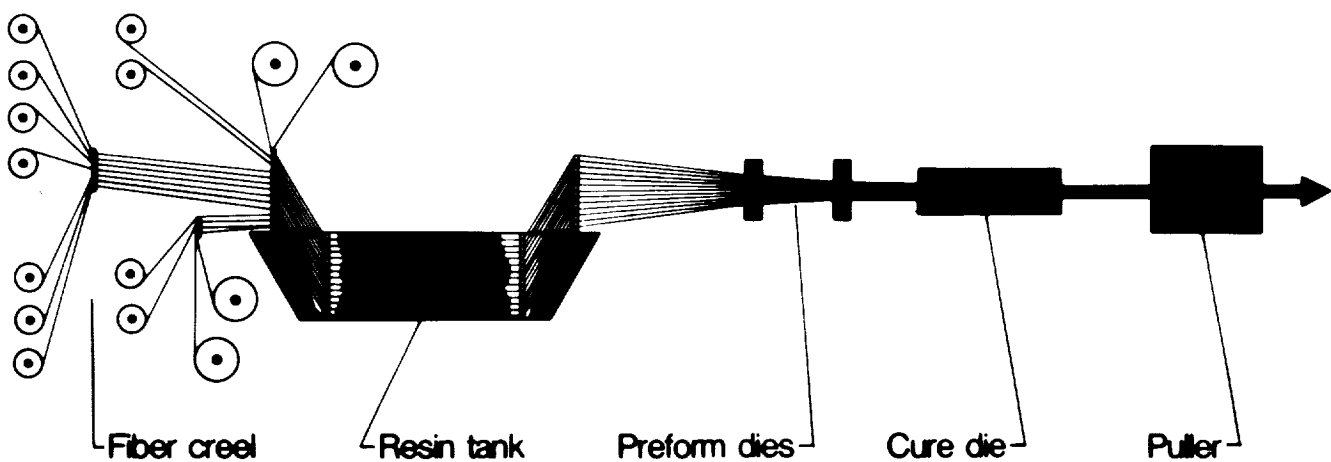
Figure 2. Pultrusion process.

The continuous-reinforcement pultrusion method was used to produce the beams at a rate of 1 ft per minute. Rolls of the reinforcement materials were mounted on a creel and pulled through a resin bath. Each ply was separated by holddown spreader bars as it traveled through the resin system. (See fig. 2.) Approximately 1741 ft of material was pultruded in nine runs for this project. The cure die was machined from 17-4 PH (precipitation-hardened) stainless-steel, heat-treated to Rockwell C-45, and surface-finished to 9×10^{-6} in. root mean square (rms). Electrical strip heaters were used to heat the die, and thermocouples were used to monitor and control die heat zones. (See fig. 3.) The die cross-section dimensions were constant, and its length was 30 in. Die-temperature profiles of runs 22583-5, 82483-9, and 111380 with matrices of resin systems 1, 2, and 3 (table I), respectively, are shown in figure 4. The die station with the start-up winch attached is shown in figure 5.

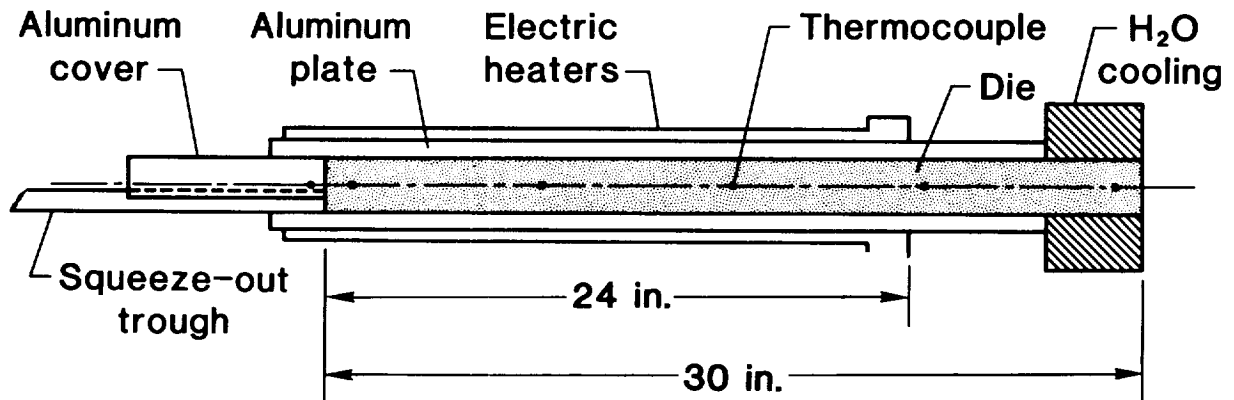
Figure 3. Profile view of pultrusion die.

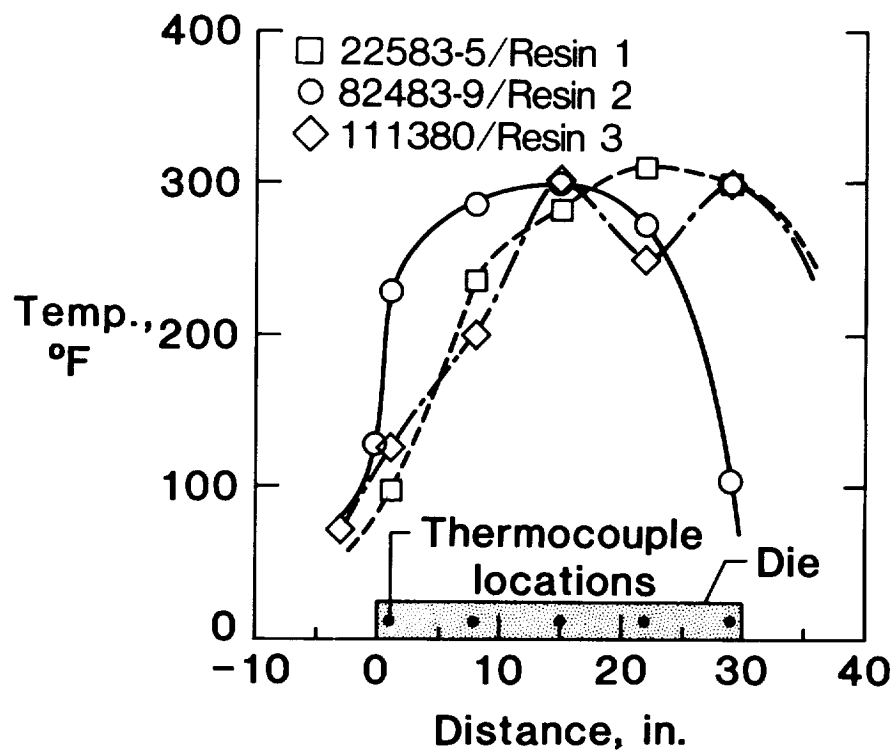
Figure 4. Die-temperature profiles of pultrusion processes.

Processing problems encountered were surface roughness, scaling, sloughing, cracking, voids, delaminations, and tapered edges. Sections of three pultrusion runs depicting surface and delamination problems (top specimen), tapered edges (center), and the developed process (bottom) are shown in figure 8. The problems were divided into the following three groups for analysis and correction: (1) resin system, (2) reinforcement material, and (3) cure cycle. Resin-related problems were surface roughness, scaling, sloughing, cracking, and delaminations. These problems were eliminated, with the exception of some scaling, by changing to resin system 2. Thermal analysis using a Dupont 1090 differential scanning calorimeter (fig. 9) shows that resin system 1 has a single catalyst with one exothermic peak and a short reaction range, whereas system 2 has a double catalyst, two exothermic peaks, and a broader reaction range. The latter system is indicative of a less violent, lower rate of reaction, which allows the resin to cure more uniformly from the center outward to the surfaces. This uniform curing process accounts for some of the process improvements made by resin system 2. The probable cause of excessive voids and delaminations in the pultrusions using resin system 1 was free moisture produced by the alumina trihydrate when it was heated to processing temperatures. Some improvements in the surface finish were achieved by adding Nexus² polyester surfacing veil style 131-10. Finally, after adjusting the die exit temperature below 240°F by installing a water-cooling unit (fig. 3) over the last 4 in. of the die, scaling was completely eliminated and an excellent surface finish was produced. A die-temperature profile of the developed process (82483-9/Resin 2) is shown in figure 4.

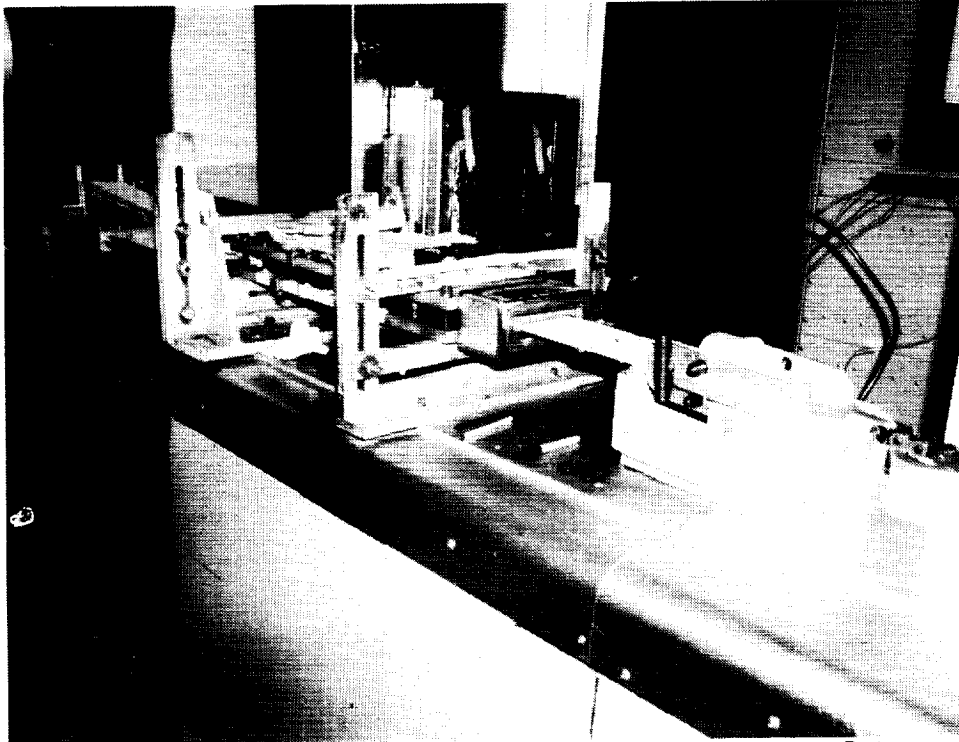
L-84-6814

Figure 5. Die station showing start-up mechanism.

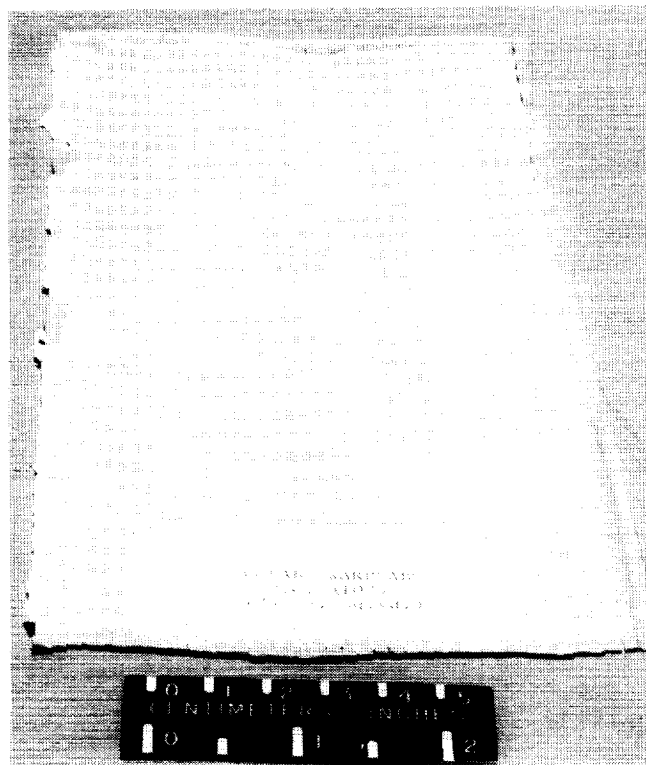
L-84-7743

Figure 6. Unidirectional material, knit-locked fiberglass.

material consists of fiberglass (electrical grade, E fabric glass) rovings locked together by a knitted polyester yarn to form a stable cloth-like fabric. (See figs. 6 and 7.) This material is available in orientations of $[0^\circ]$, $[90^\circ]$, $[0^\circ/90^\circ]$, and $[\pm 45^\circ]$ directions. Seven pultrusion runs were made with fiber orientation combinations of $[0^\circ]$ and $[0^\circ/90^\circ]$ plies, and two runs were made with all $[0^\circ/90^\circ]$ orientations.

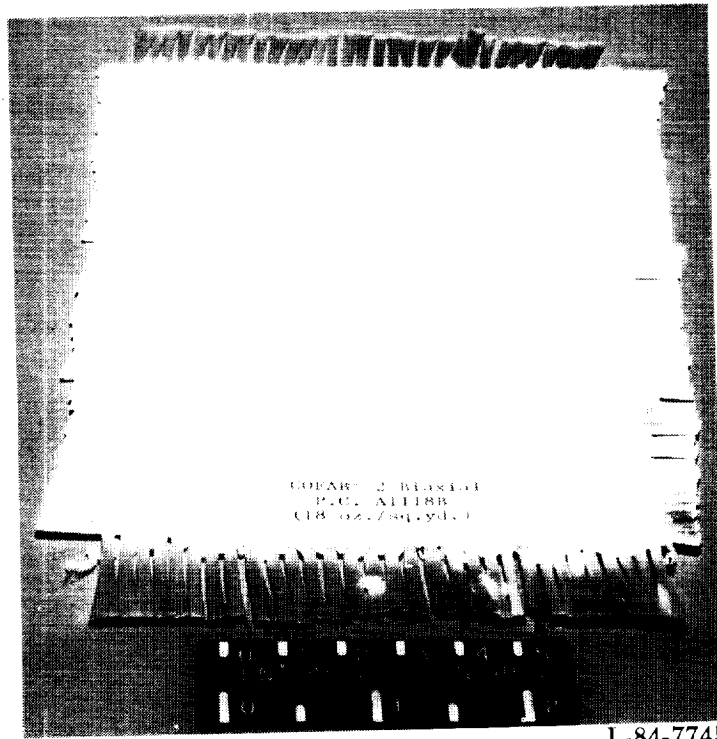
L-84-7745

Figure 7. Biaxial material, knit-locked fiberglass.

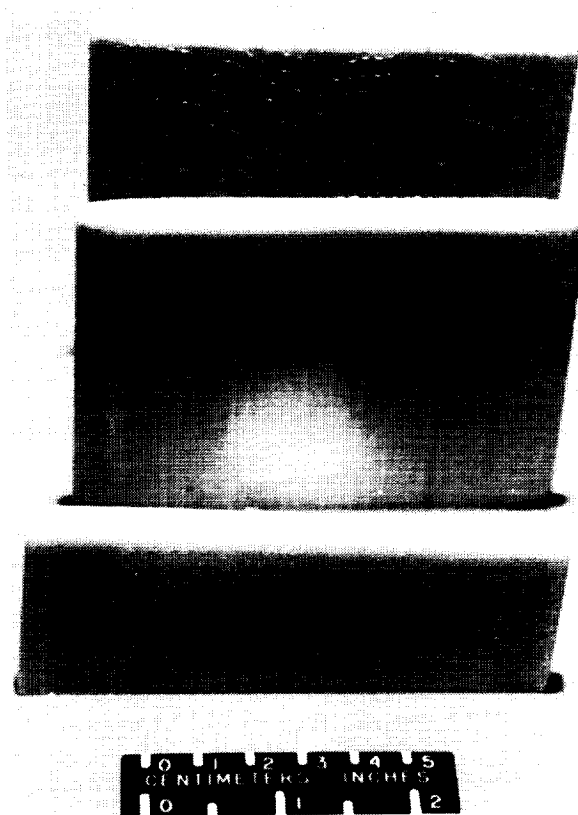
L-84-7741

Figure 8. Sectioned pultrusions showing defects.

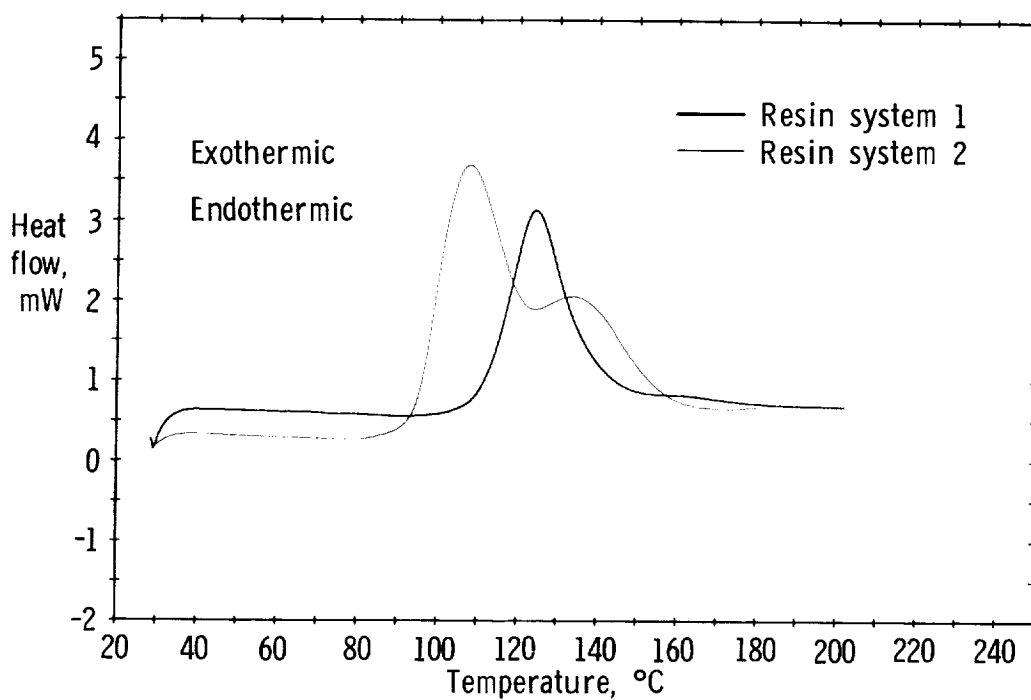
Figure 9. Differential scanning calorimeter (DSC) thermogram of polyester resins.

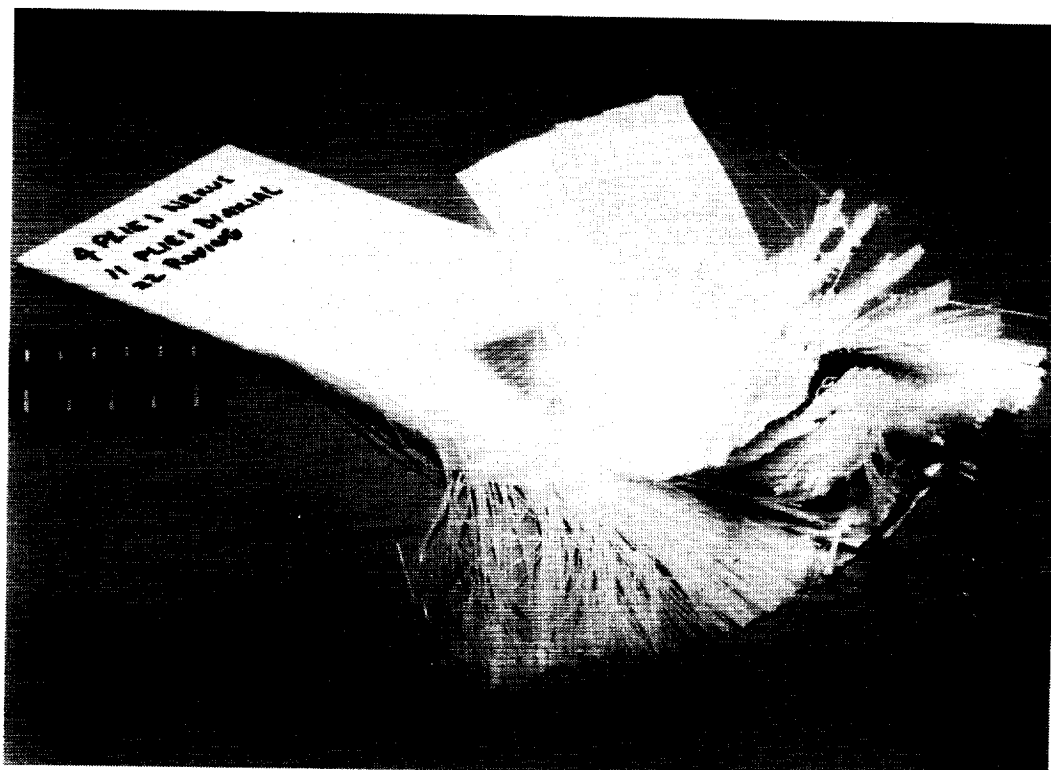
L-84-7742

Figure 10. Start-up end of pultrusion run.

by adding $[0^\circ]$ roving. The final reinforcement lay-up consisted of two plies of Nexus veil; 11 plies of $[0^\circ/90^\circ]$ biaxial COFAB, 18 oz/yd²; two rovings 30 K (see ref. 1), 112.5 yd/lb yield for each $[0^\circ/90^\circ]$ biaxial ply (one such roving applied to each outside edge); and two plies of Nexus veil, style 131-10 (fig. 10).

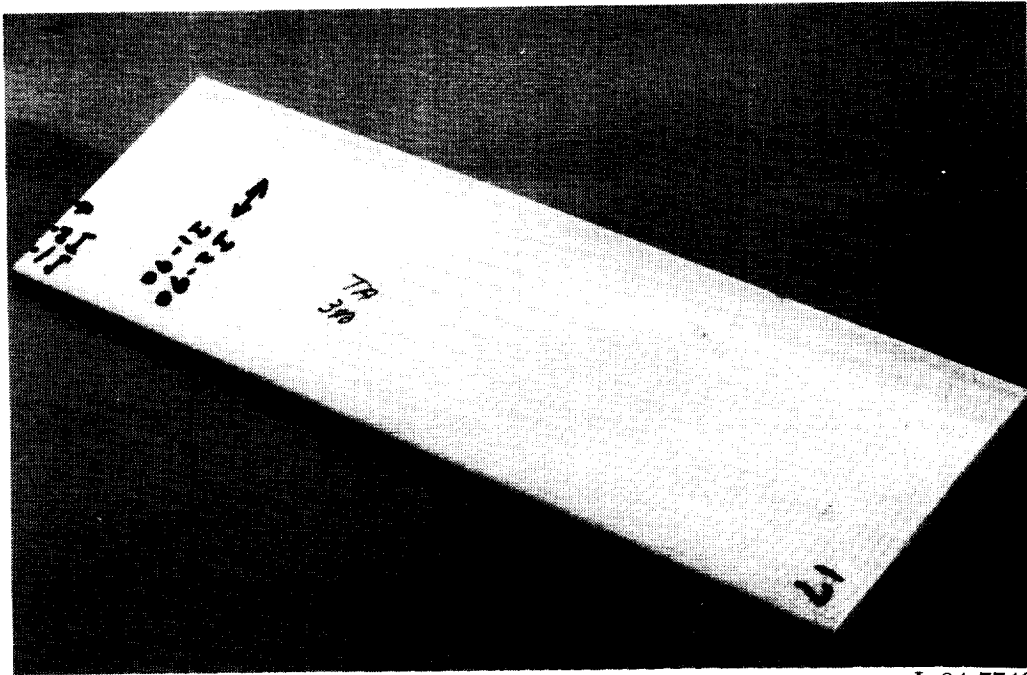
L-84-7746

Figure 11. Section of pultrusion run 82483-9.

Identical tests were conducted on samples sectioned from pultrusion runs 82483-9, the final developed beam model (fig. 11); 22583-5, a beam-model run made during the development stage; 111380, which contains all unidirectional roving with cross-sectional dimensions of 0.125 in. thick by 1.0 in. wide; and a commercially produced 6-in. H-beam. Physical and mechanical tests results are listed in table III. Fiber volume and weight percent determinations were made by gravimetric analysis. Tensile, flexural, and short-beam shear tests were based on American Society for Testing and Materials (ASTM) Standards D638, D790, and D2344, respectively. These tests were conducted on an Instron testing machine³ Ultrasonic C-scan and Scanning Electron Microscope (SEM) evaluations supported physical and mechanical test results. C-scan test results (figs. 12 to 16) show the following order of quality: (1) 111380, (2) 82483-9, (3) 6-in. H-beam web, (4) 6-in. H-beam flange, and (5) 22583-5. In the photographs, black indicates good quality and white indicates poor quality. The unidirectional roving pultrusion (fig. 12, 1-in-wide strips with white tabs) appears to transmit the highest volume of sound (black), which is indicative of the lowest void content, better fiber wetting, a higher degree of resin-fiber interface bonding, and an absence of delaminations. Scanning Electron Microscope photographs (figs. 17 to 20) show that 111380 (fig. 17) has the best fiber wetting, followed by 82483-9 (fig. 18), 22583-5 (fig. 19(a)), and the H-beam (fig. 20(a)). Internal microcracks and excessive voids in the polished cross section of 22583-5 are shown in figure 19(b). Internal microcracks in the polished cross section of the H-beam are shown in figure 20(b).

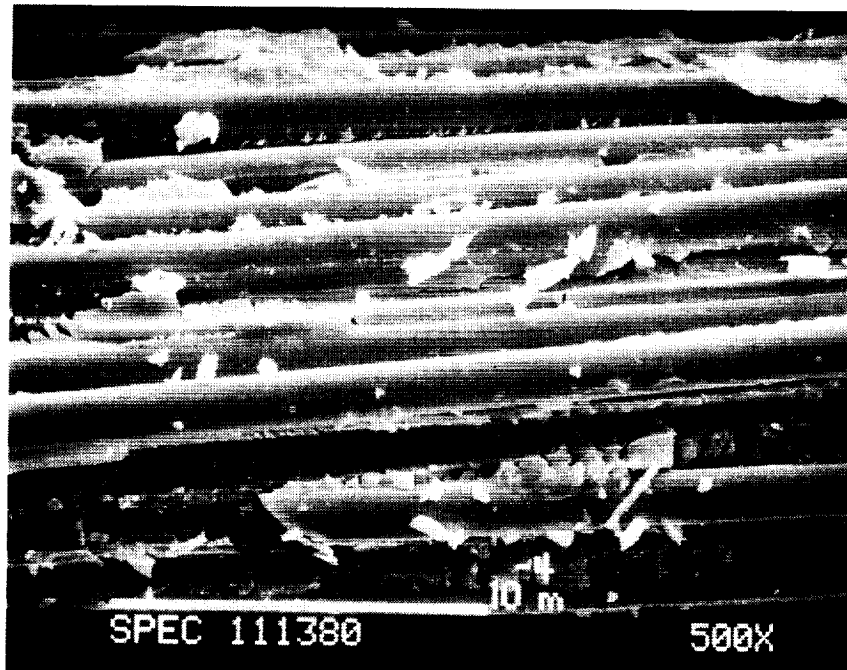
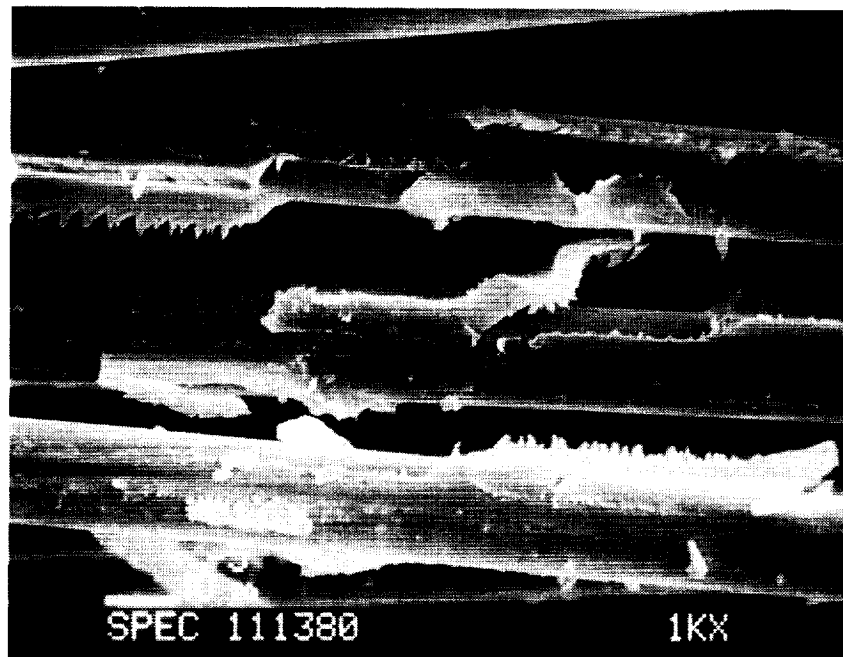
L-87-665

Figure 17. Photomicrographs of fracture-face samples from pultrusion run 111380.

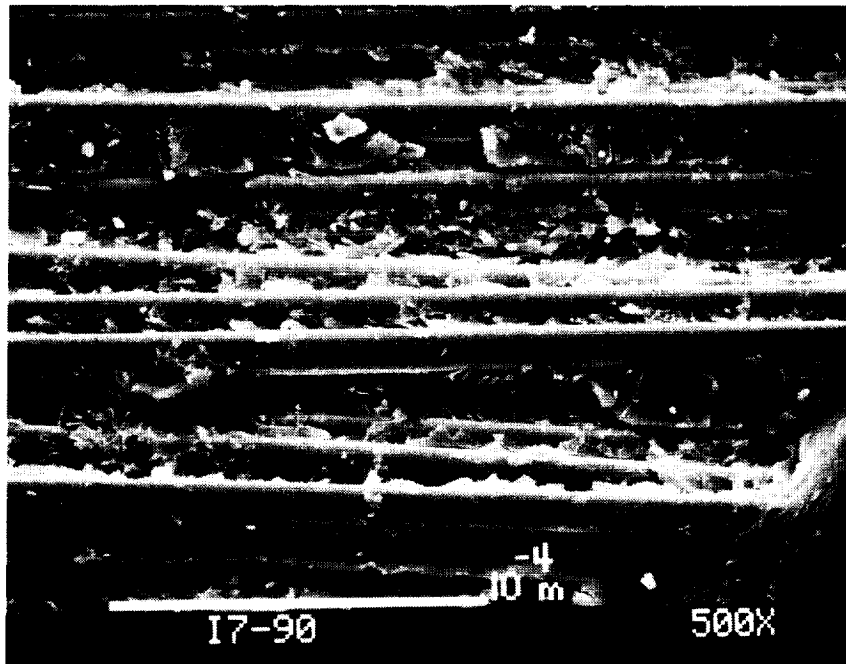
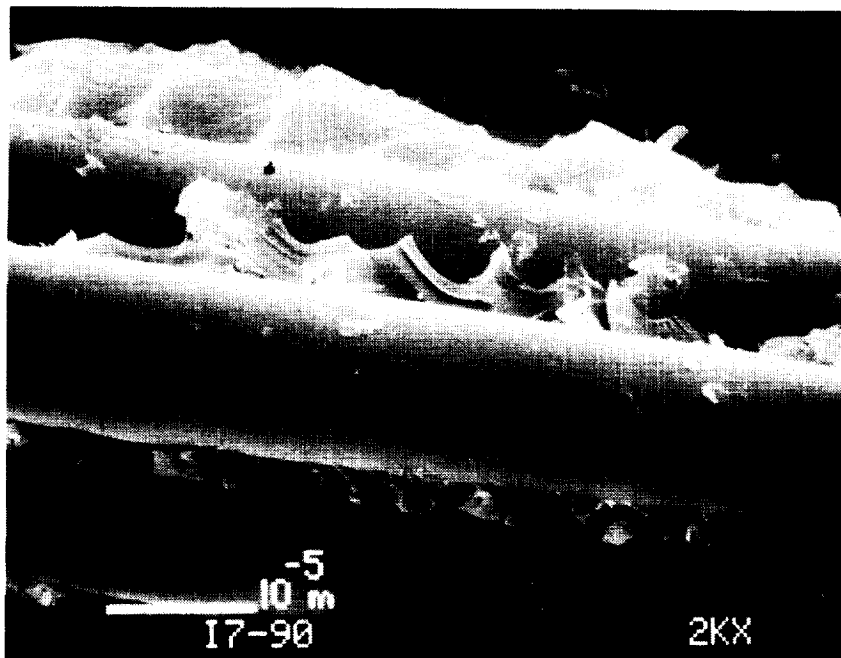
L-87-666

Figure 18. Photomicrographs of fracture-face samples from pultrusion run 82483-9.

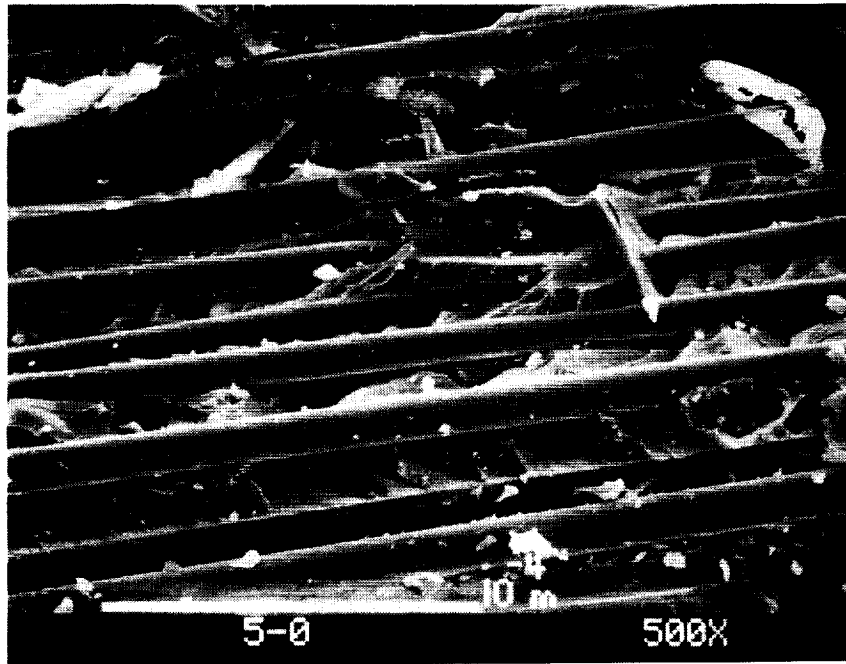
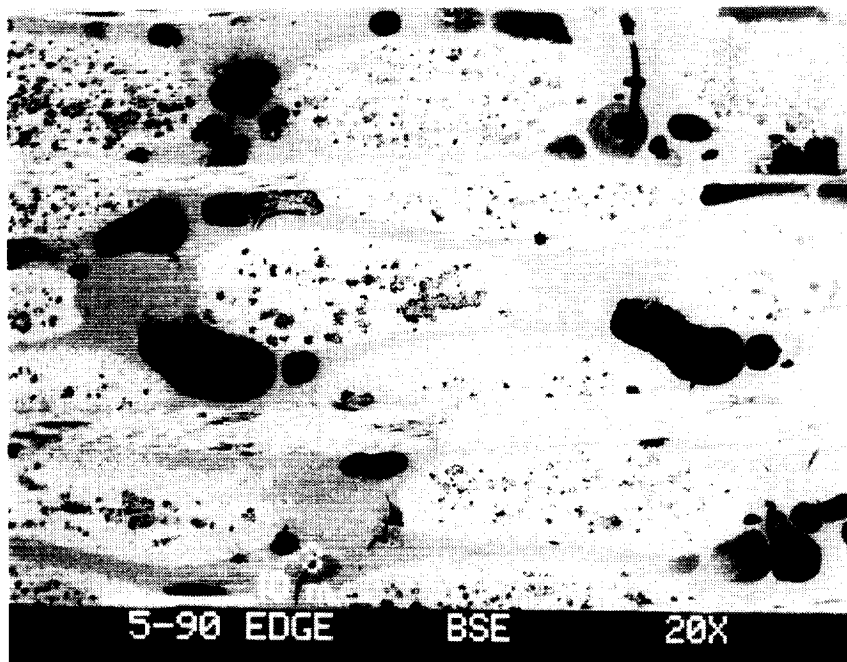
L-87-667

(a) Fracture face.

(b) Cross section.

Figure 19. Photomicrographs of samples from pultrusion run 22583-5.

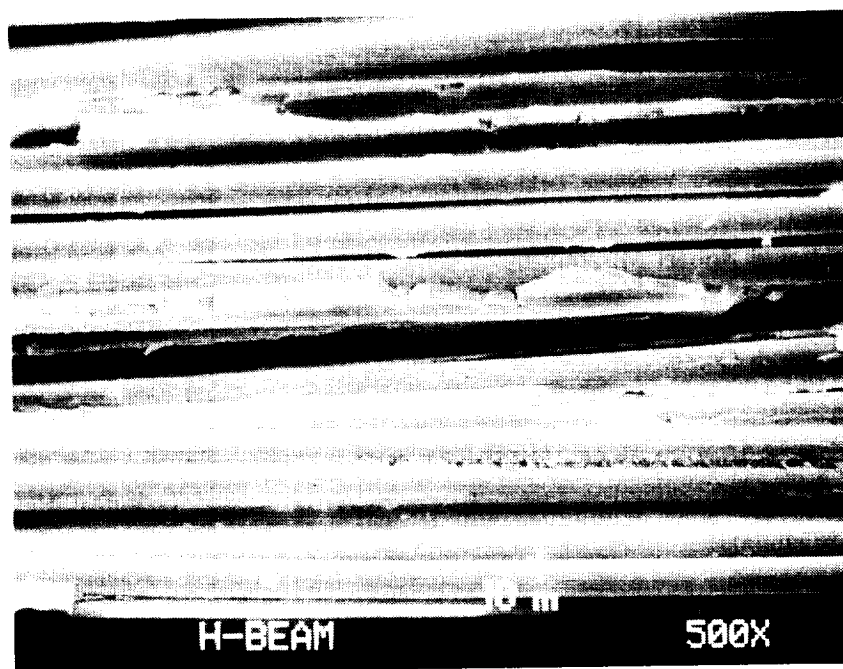
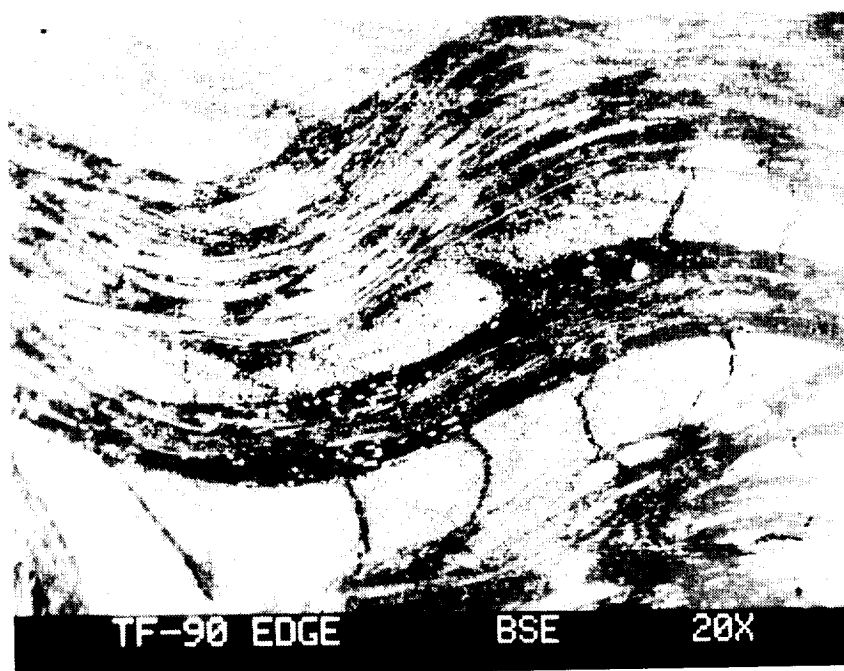
L-87-668

(a) Fracture face.

(b) Cross section.

Figure 20. Photomicrographs of samples from H-beam pultrusion.
